**NP300 - Navara**

# TechLine

## Issue Details - 1199166

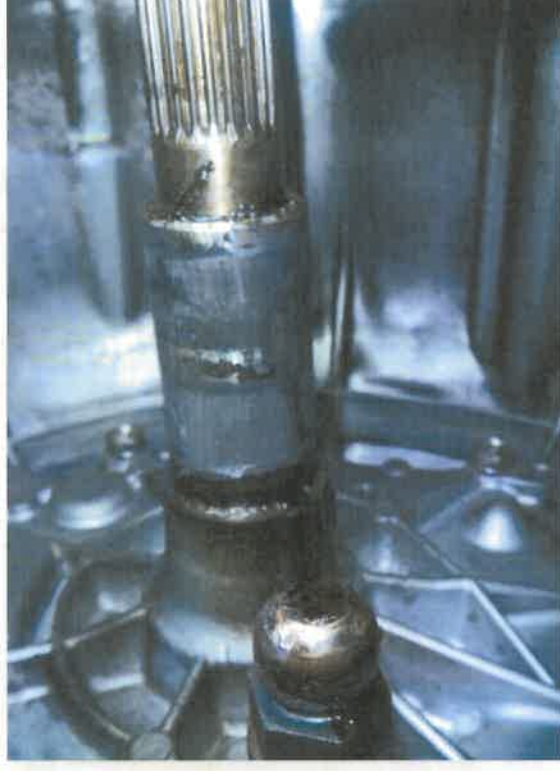
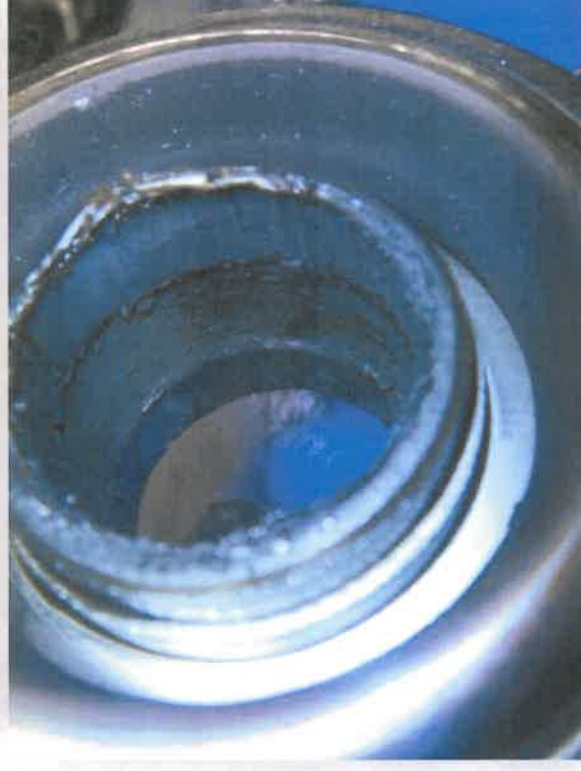
- **TECH INFO 98**

Clutch operation sticks or is not smooth in operation.

Release bearing has insufficient lubrication

Replacement of release bearing and gear box snout, apply sufficient grease as per tech info 098.

Lithium based molybdenum disulphide grease must only be used

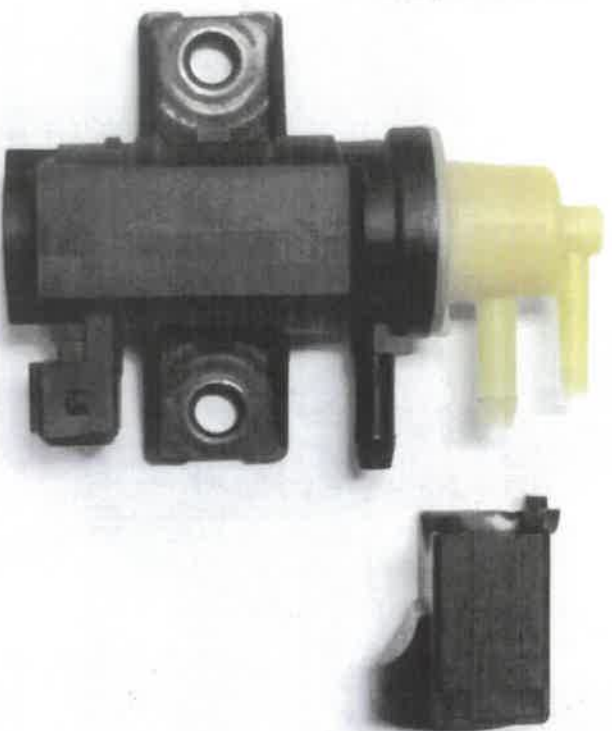
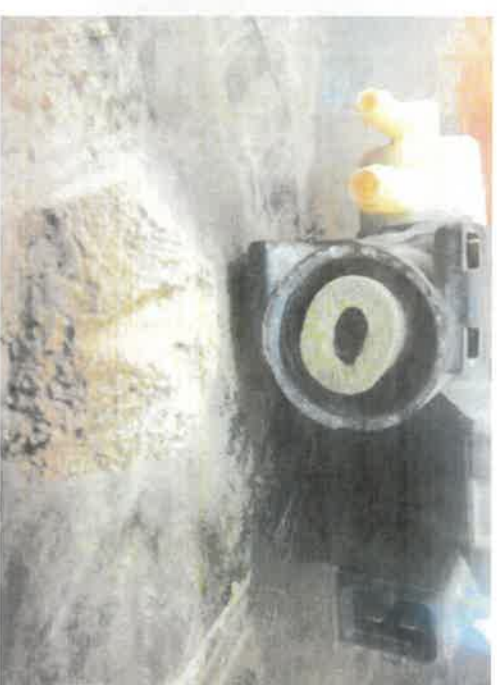
- Lack of power while driving / low boost available
- Mil light on with DTC's P0471 or P2263

- Additional to Tech Info 038 faults discovered
- Port filter on solenoids block with dust or debris
- Effects cars used in off road applications

- Refer to Tech Info 072 for repair procedure.

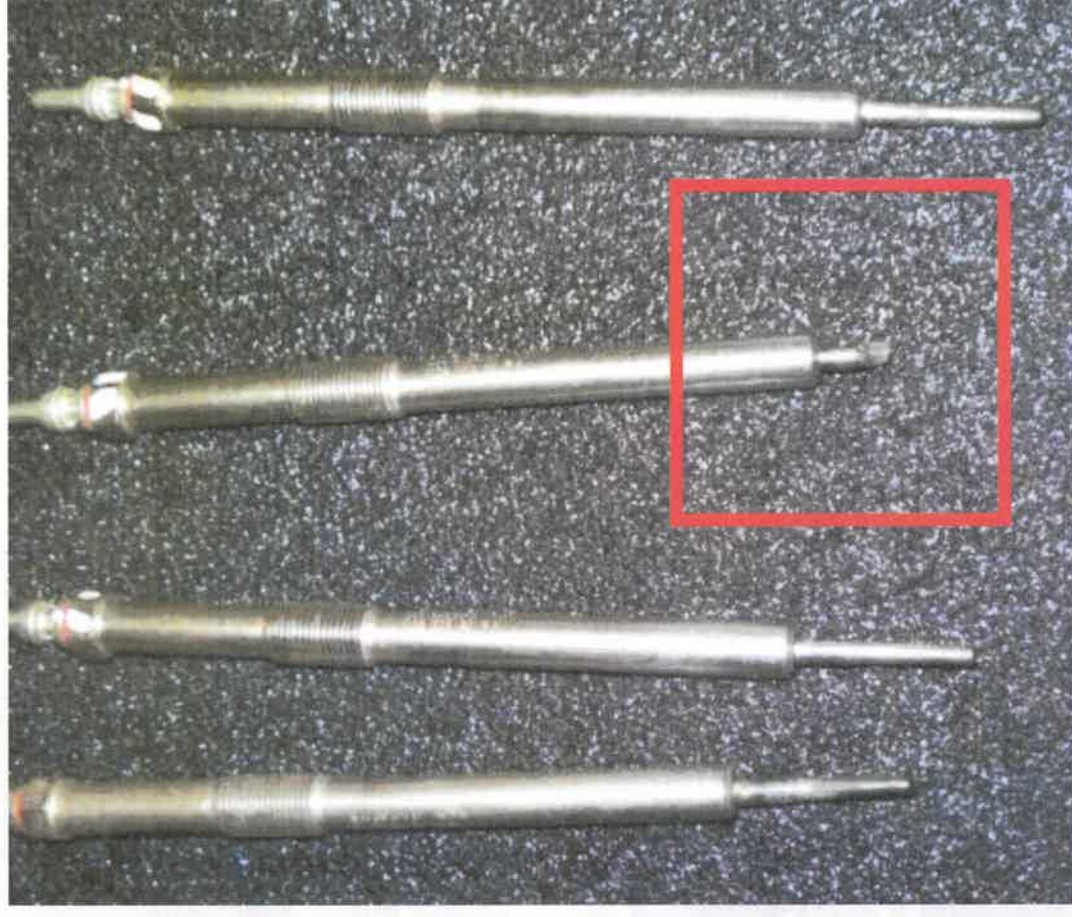
**Complaint : Noise from engine and runs rough**

**Cause : Glow tip snapped off due to possible excessive high voltage spike on start up**

**Correction : Concern is still under investigation, looking at possible ECU programming, Engineering has requested further IQ case contacts if this concern has been noted.**

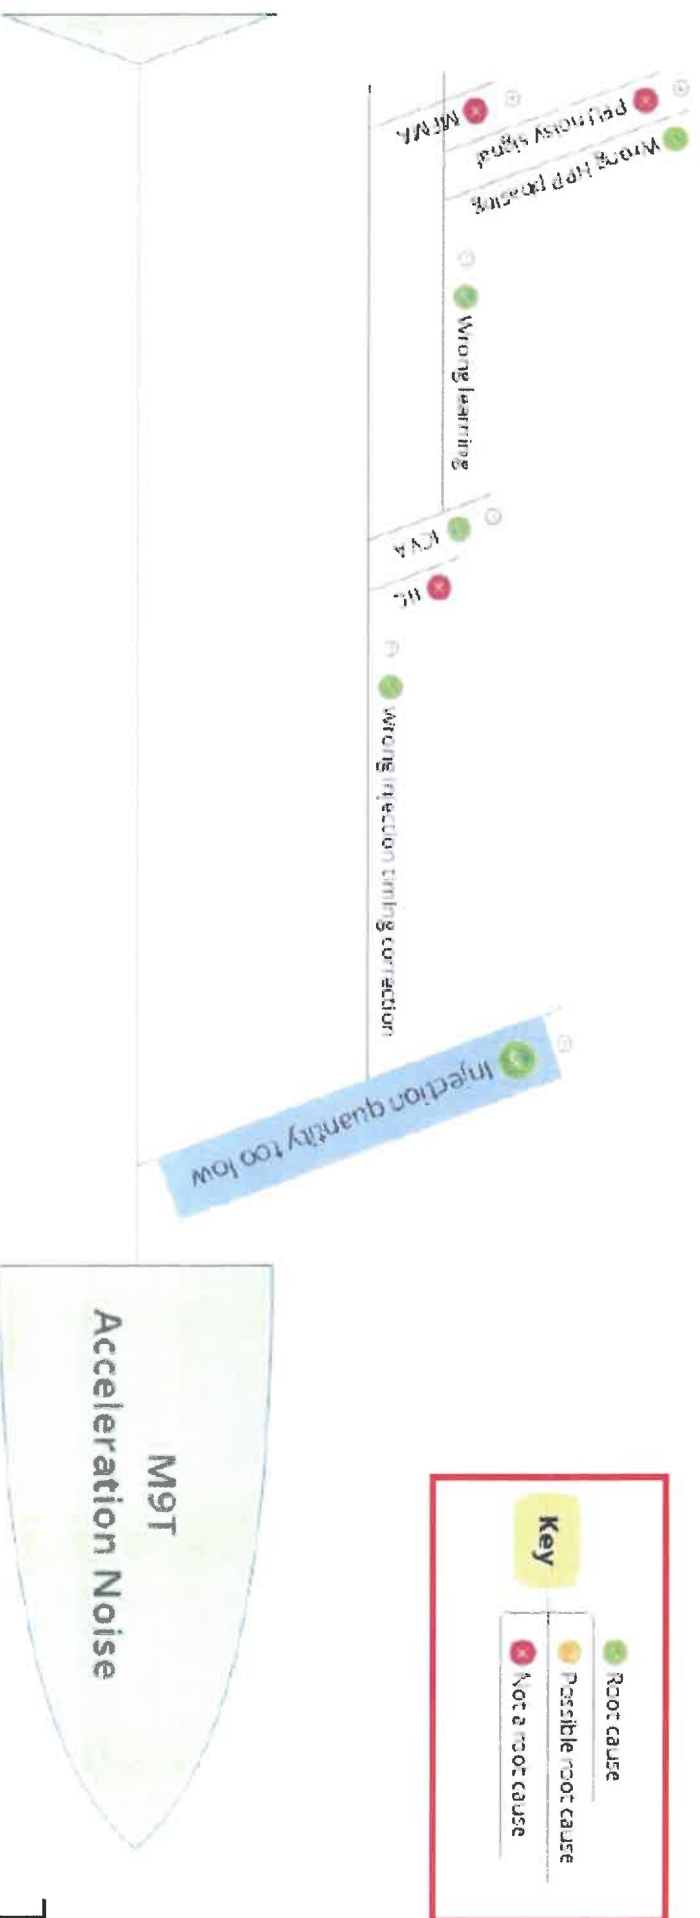
Complaint : Knocking noise from engine comes back again

Cause : Fuel pump timing incomplete, the physical symptom being that the injector flow is reduced because of wrong correction from ICVA (Injector Control Valve Adaptation).

The noise is coming from an excessive reduction of the Injection Timing (Ti) applied to the injector. It can lead to cut the pilot injections quantity becoming too low.

Correction :Fuel pump timing to be checked as per FFL18-001

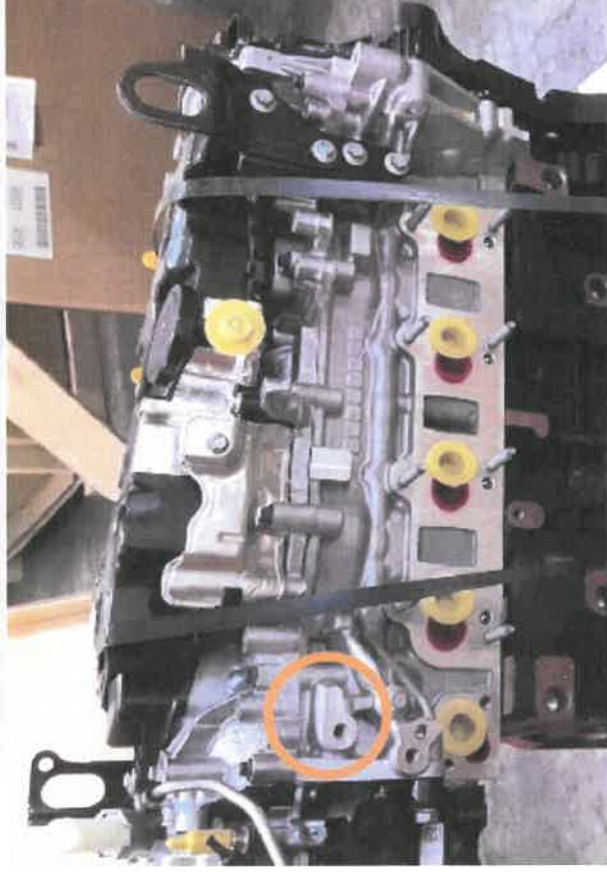
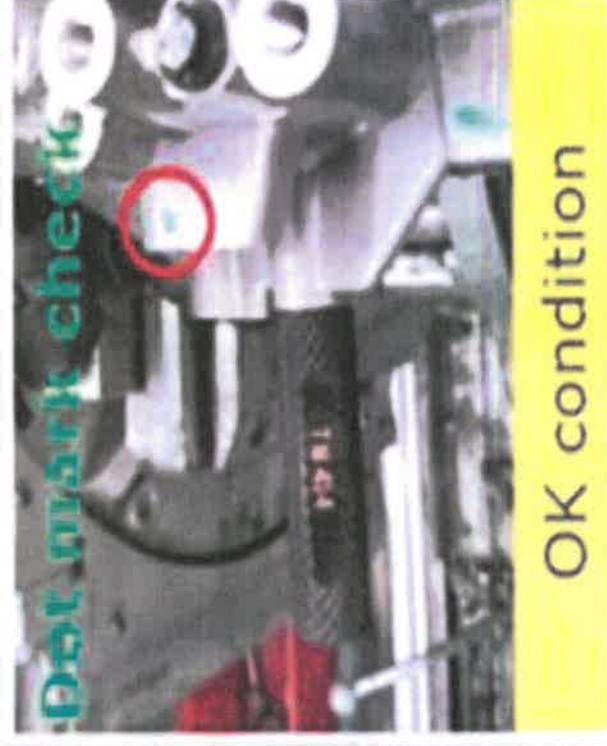
**Complaint:** Knocking noise apparent after injector relearn

**Cause:** Pump phasing not timed with camshaft

**Green dot check before 1<sup>st</sup> March build production**

**MUST COMMUNICATE WITH TECHLINE BEFORE CONDUCTING**

2. Confirm dot mark check with next process  
→ [Adoption ENG. no YS23-356152A \(1 Mar '17\)](#)

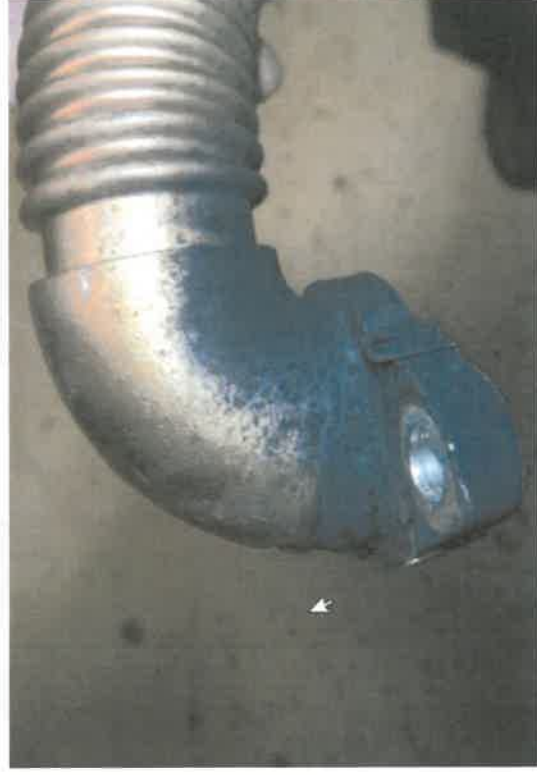
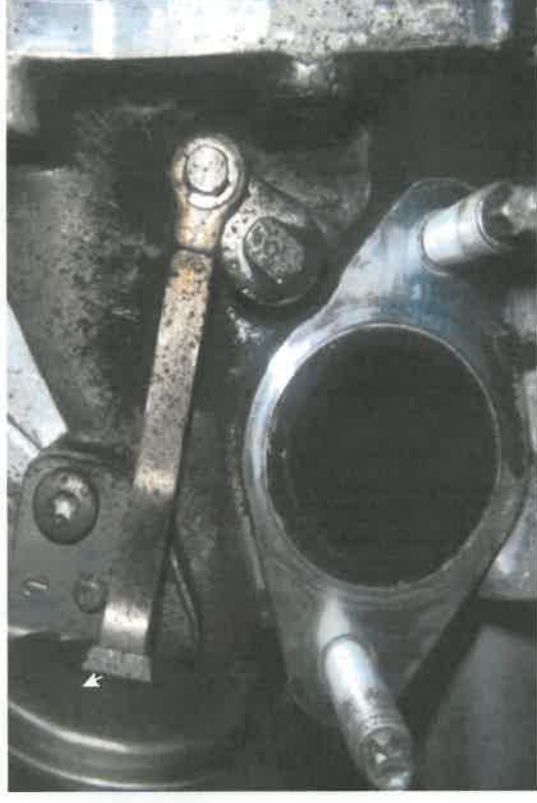
High pitched whine noise while under acceleration  
Can be easily mistaken for Turbo whistle type noise

EGR pipe fracture or EGR pipe flange gasket leak

- Sound can be mistaken for injector tapping or knock (pipe fractured)
- Turbo replacement has been carried out for this issue with no resolution.
- Don't get caught out with miss diagnosis.

- Replacement of EGR pipe and gasket is required

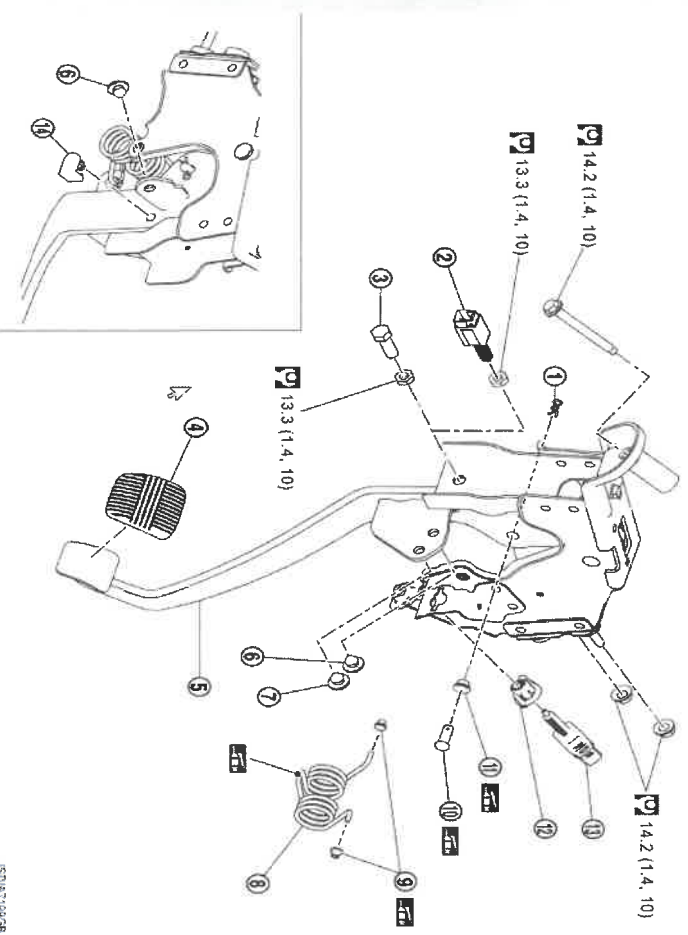
- I - key warning light in ADAD
- Engine will not engage starter motor unless gear lever is in neutral position

- ECM and BCM logic detects an incorrect clutch pedal position
  - Clutch pedal depressed for more than 30 gear changes without release above first gear, combined with accelerator input being received (riding/resting on the clutch pedal)
- DTC's logged in BCM and ECM
  - P0833-29 Clutch switch signal inconsistency (Clutch pedal switch "B" circuit)
  - B26E8 Clutch switch
  - B26FB Clutch switch

- Refer to Tech Info 067 for further info
- Confirm adjustment of clutch pedal position 1 as per ESM
- Customer education
  - Refer to Starting and driving section in owners manual.

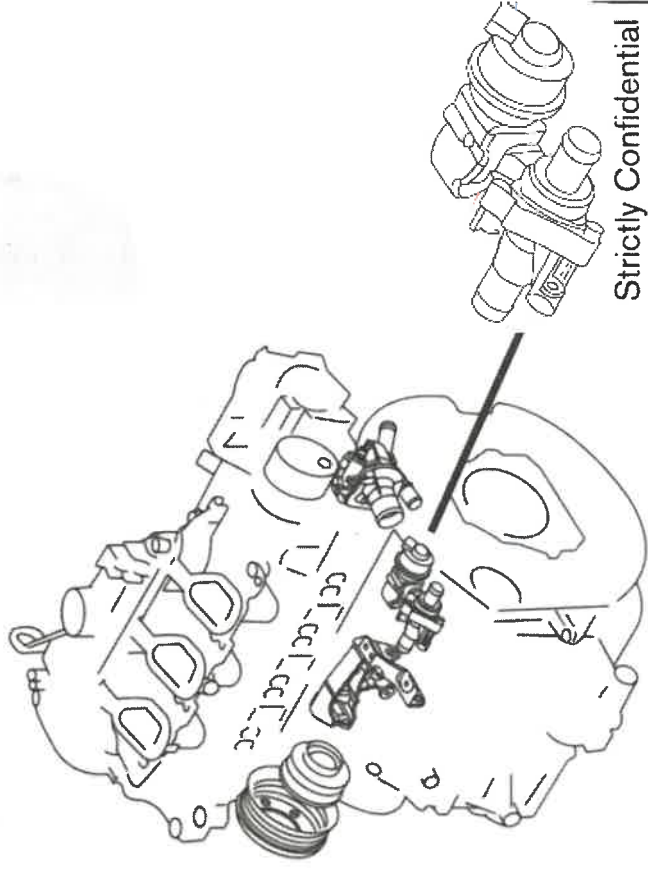
Heater is not getting hot, blows cool air and engine temperature gauge only reaching ~75deg C

Thermo management control solenoid not operating

Check Thermo management control solenoid via work support and confirm if the solenoid not can be operated in its full travel

- Listen for clicking noise
- Otherwise remove and conduct work support
- Replacement of the valve is necessary
